Thermography Report

Any Customer
Anytown, NH

Thermography date: (Date)

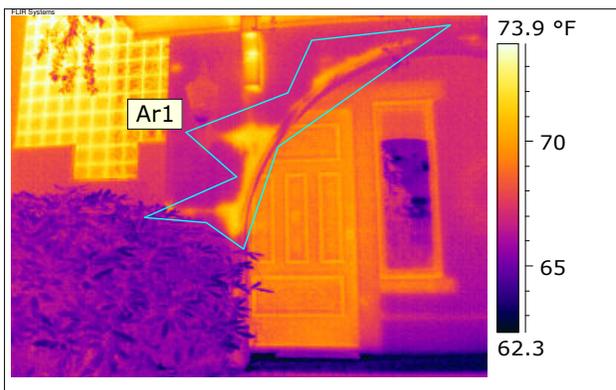
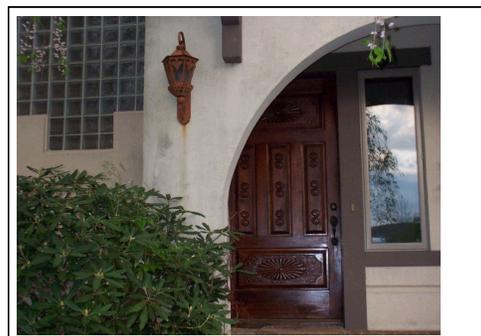
Picture 1. Captured at: Main Entrance

Moisture Content: High

Comment: An elevated moisture is present in the lighter sections of area #1

Recommendation: Recommend removal of the stucco finish and repair as needed. Replace the deteriorated wooden trim above this area and reseal.

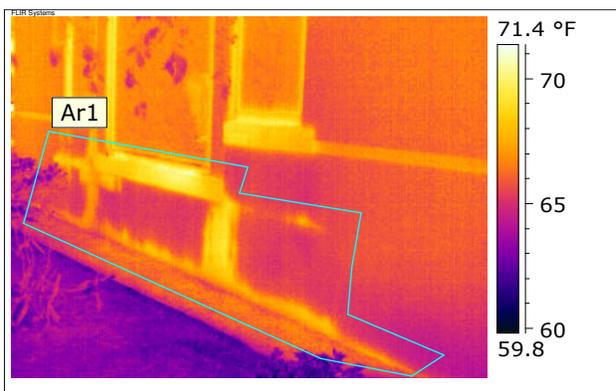
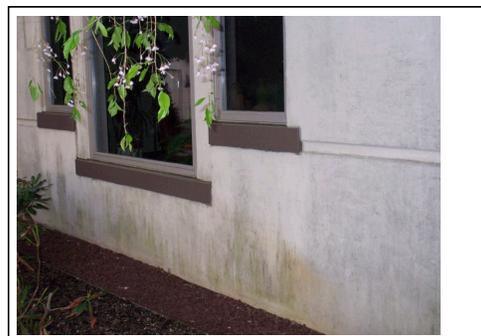
Picture 2. Captured at: Left front

Moisture Content: High

Comment: An elevated moisture is present in the lighter sections of area #1

Recommendation: Replace the rotted window and remove the stucco finish and repair as needed.
