Thermography Report

Any Customer
Any Street
Any Town, NH 00000

Thermography date: August 29, 2006

Shakes to Shingles Inspection Services
PO Box 2142, Concord, NH 03302

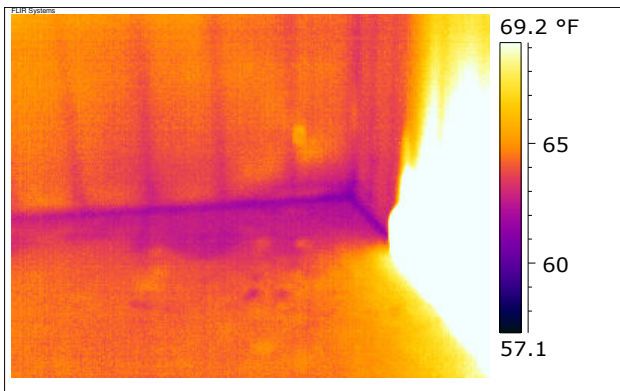
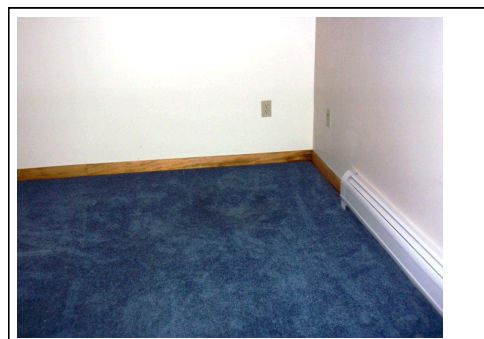
Picture 1. Captured at: Basement-right rear room

Moisture Content: High
Comment: Elevated moisture content in the darker areas of the floor.

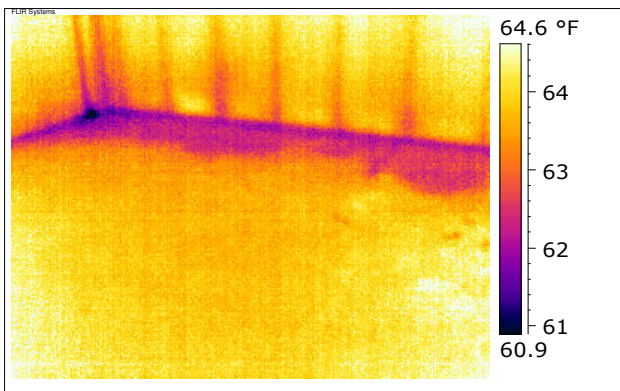
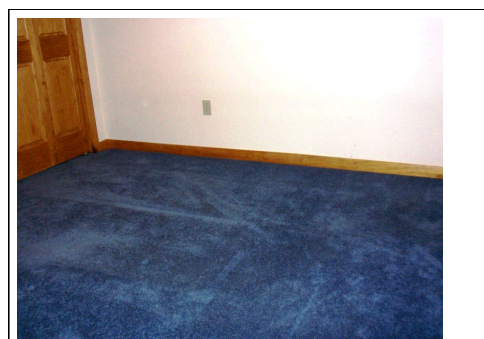
Picture 2. Captured at: Basement-right rear room

Moisture Content: High
Comment: Elevated moisture content in the darker areas of the floor.
